INTEGRATED STUDIES FOR THE EVALUATION OF CONSERVATION TREATMENTS ON BUILDING MATERIALS FROM ARCHAEOLOGICAL SITES. APPLICATION TO THE CASE OF MERIDA (SPAIN)

Natalia PEREZ EMA^{1,2,3*}, Monica ALVAREZ DE BUERGO², Rosa BUSTAMANTE³

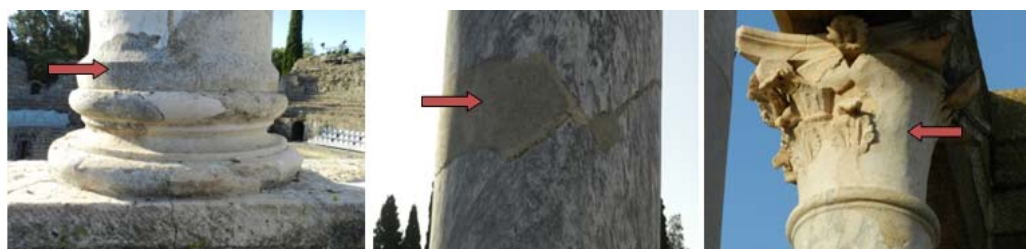
Fig. 3. Restoration mortars used in different periods for the structural consolidation of the Front stage in the Roman Theater of Merida (Photos by Natalia Perez)

- The degree of deterioration/preservation of materials can be checked before intervention, in order to search for compatibility of materials. The anisotropy of the material determines some deterioration processes as it strongly influences some kind of behavior, such as the capillary absorption one. Thus, it should be considered when placing and orienting new stone material on ancient structures as a preventive conservation method [4]. When studying restoration mortars, UPV permits to analyze how they work on site, their performance in the structure, in terms of compatibility or efficiency. In the case of Merida many types of mortar have been used, for structural consolidation, both in the reconstruction of the Front stage of the Roman Theater (Fig. 3) and in the restoration of mural paintings and mosaics at Mitreo's House. By analyzing the state of junction and the different internal strength between the original material and mortar restoration, and comparing with different types of plaster used (including the original Roman plaster), it is possible to determine the most compatible one, and detect, or prevent, future degradation processes regarding the quality of those ones. In this case, direct mode of UPV, when possible, provides more representative outcomes.

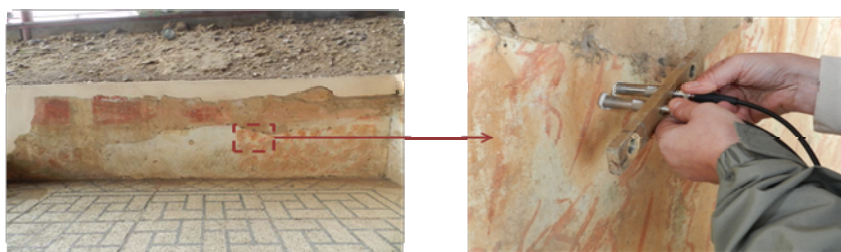
Treated area: 2182 m/s

Untreated area: 1611m/s

Fig. 4. UPV measurements on SDH13MA wall from Mitreo's House (Photo by Natalia Perez)

- UPV is especially useful when evaluating the efficacy of consolidative treatments [5, 6]. Measurements, in indirect mode, have been carried out on some wall paintings from Mitreo's House using transducers with a flat contact surface diameter of 12 mm and 1 MHz of energy. In the example showed in figure 4, comparative analysis results in a remarkable difference between treated (with Paraloid B72©) and untreated areas of the same panel. Values will allow us to assess the effectiveness of consolidative treatments applied in terms of higher strength of this area; nevertheless it should be correlated with other parameters, such as, for instance, chromatic measurements, in order to confirm a positive judgment.
